EFFECTS OF THE LOMA PRIETA EARTHQUAKE  
ON THE MARINA DISTRICT  
SAN FRANCISCO, CALIFORNIA

OPEN-FILE REPORT 90-253

Menlo Park, California

April 20, 1990

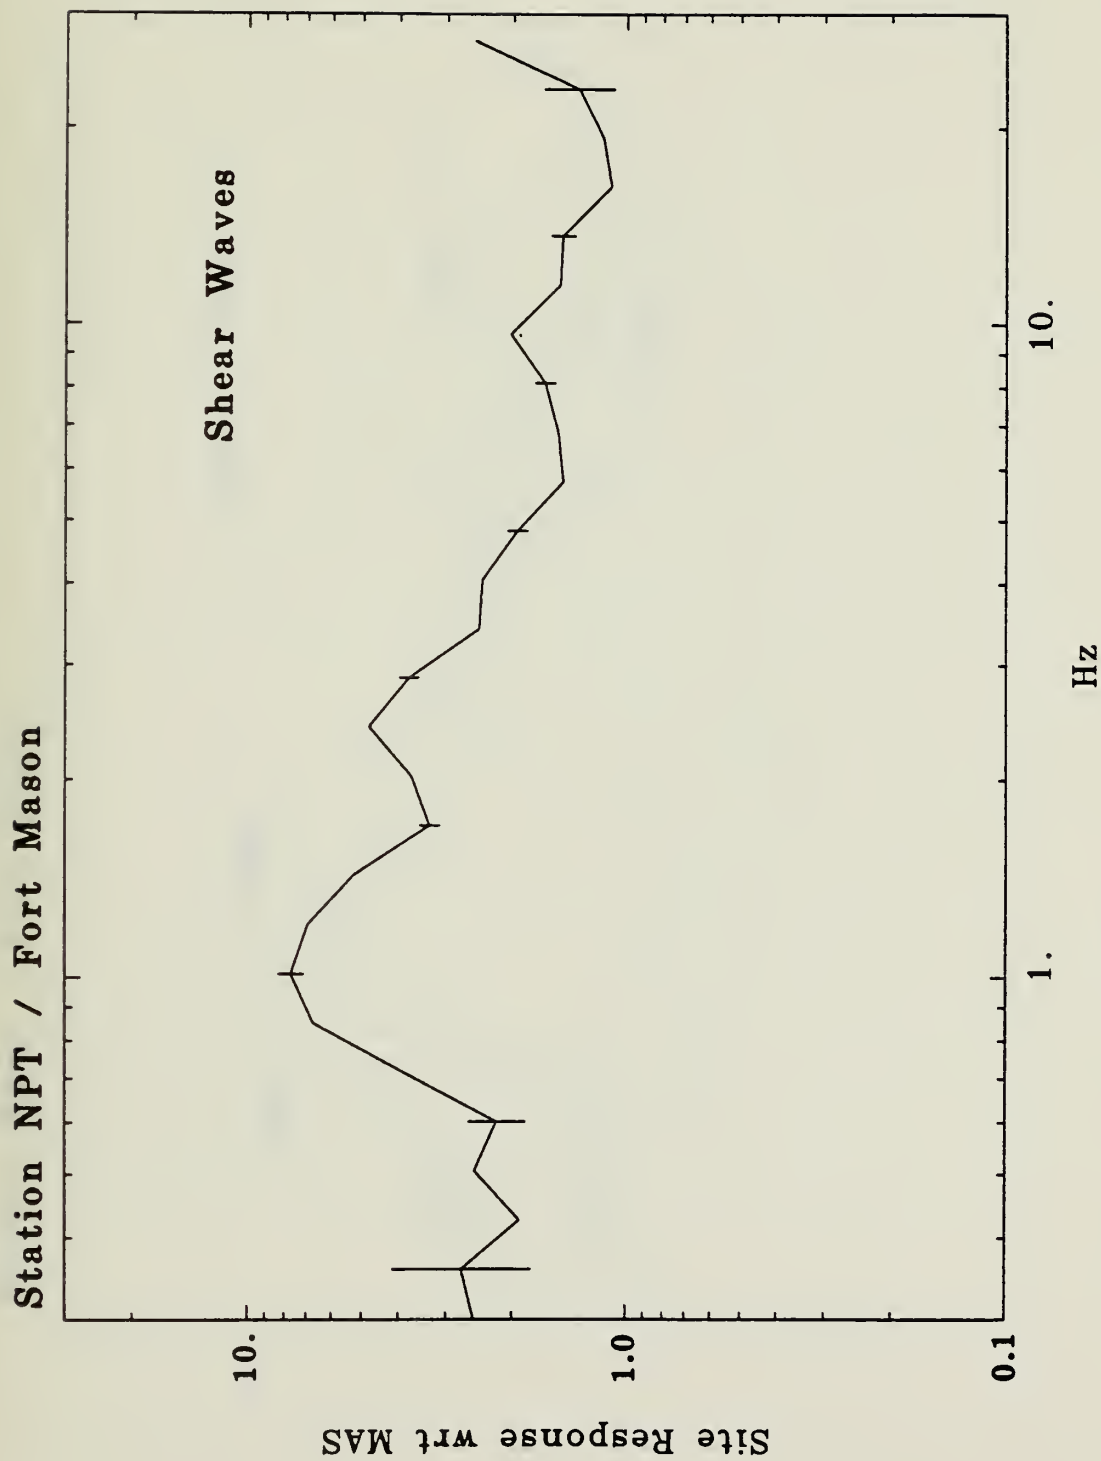
Figure 5 shows the site response of station NPT relative to station MAS; station NPT is located near the corner of North Point and Divisadero in an area which suffered significant damage during the main shock. The relative site response is well determined within the frequency band from 0.6 Hz (1.6 s) to 15 Hz. The site response is amplified by a factor of 7 near 1 Hz and decreases gradually with increasing frequency up to 15 Hz. At the lowest frequencies, the amplification is approximately a factor of 2.

Figure 5. Site response spectrum for station NPT, relative to station MAS. The vertical bars show the 85% confidence interval for the spectral estimates. The relative site response is well determined from 0.7 to 15 Hz. At low frequencies, the relative amplification is slightly larger than a factor of 2. The amplification peaks around 1 Hz and decreases gradually with increasing frequency until 15 Hz, where the amplification  $\approx 1$ .

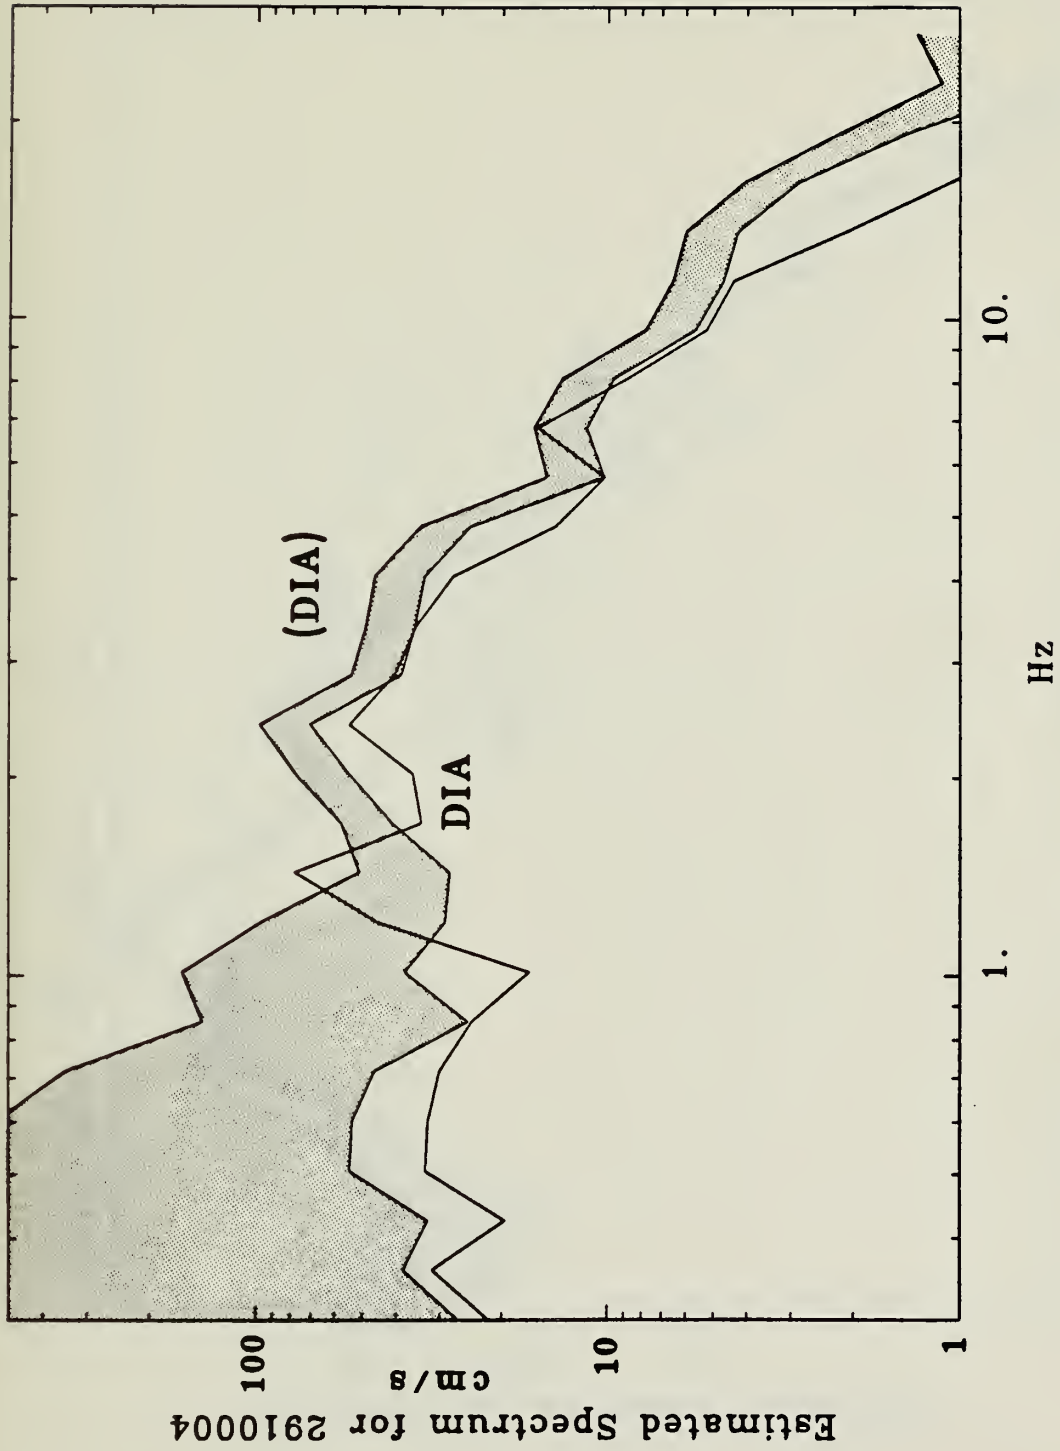
Figure 8

Figure 8. Comparison of the extrapolated acceleration spectrum with the recorded acceleration spectrum for the main shock at station DIA. The extrapolated spectrum, indicated by the shaded region, slightly overestimates the recorded spectrum on the frequency band from 1 to 10 Hz. The mismatch at frequencies below 1 Hz is caused by the malfunctioning recorder. Note that only three recordings were used to determine this extrapolation (see Table), of which only one was within the aftershock zone; the other two events were small earthquakes which occurred near Daly City.

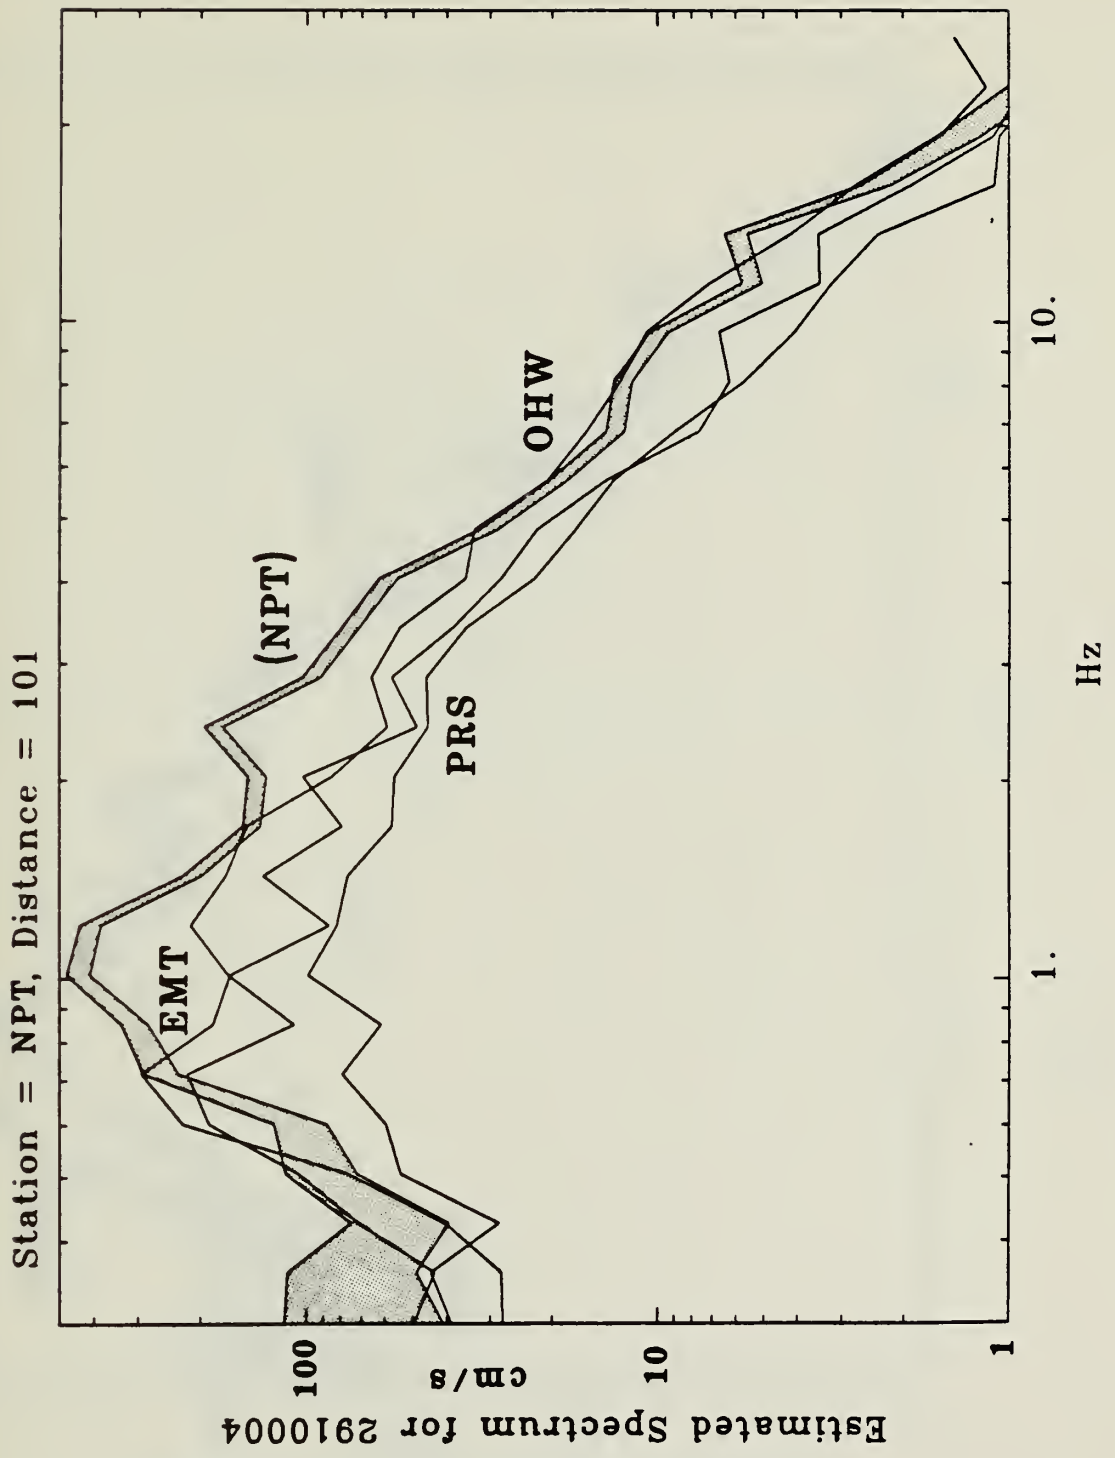
The extrapolated acceleration spectrum for station NPT is plotted in Figure 9 using 85% confidence limits. As plotted in Figure 5, the amplification for station NPT has a broad peak at 1 Hz and a "side lobe" at 2.3 Hz; these peaks are clearly evident in the extrapolated acceleration spectrum. The acceleration spectra from three accelerographs which recorded the main shock are also plotted in Figure 9. The spectrum labelled PRS was obtained from an accelerogram recorded  $\approx 1.5$  km to the southwest of the Marina in a small building on the Presidio Golf Course. The spectrum labelled EMT was obtained from free-field accelerograph in Emeryville. Finally, the spectrum labelled OHW was obtained from an accelerograph at the Outer Harbor Wharf in Oakland which recorded the largest accelerations of any site located north of the San Francisco Airport.

Figure 9. Comparison of the extrapolated acceleration spectrum for the main shock at station NPT with the recorded acceleration spectra from three accelerograph sites. The extrapolated spectrum is plotted as a shaded region. Station PRS is located on the Presidio Golf Course, Station EMT is in Emeryville, and station OHW is at the Outer Harbor Wharf in Oakland. These three accelerographs recorded peak accelerations of 21%, 25% and 29% g, respectively.

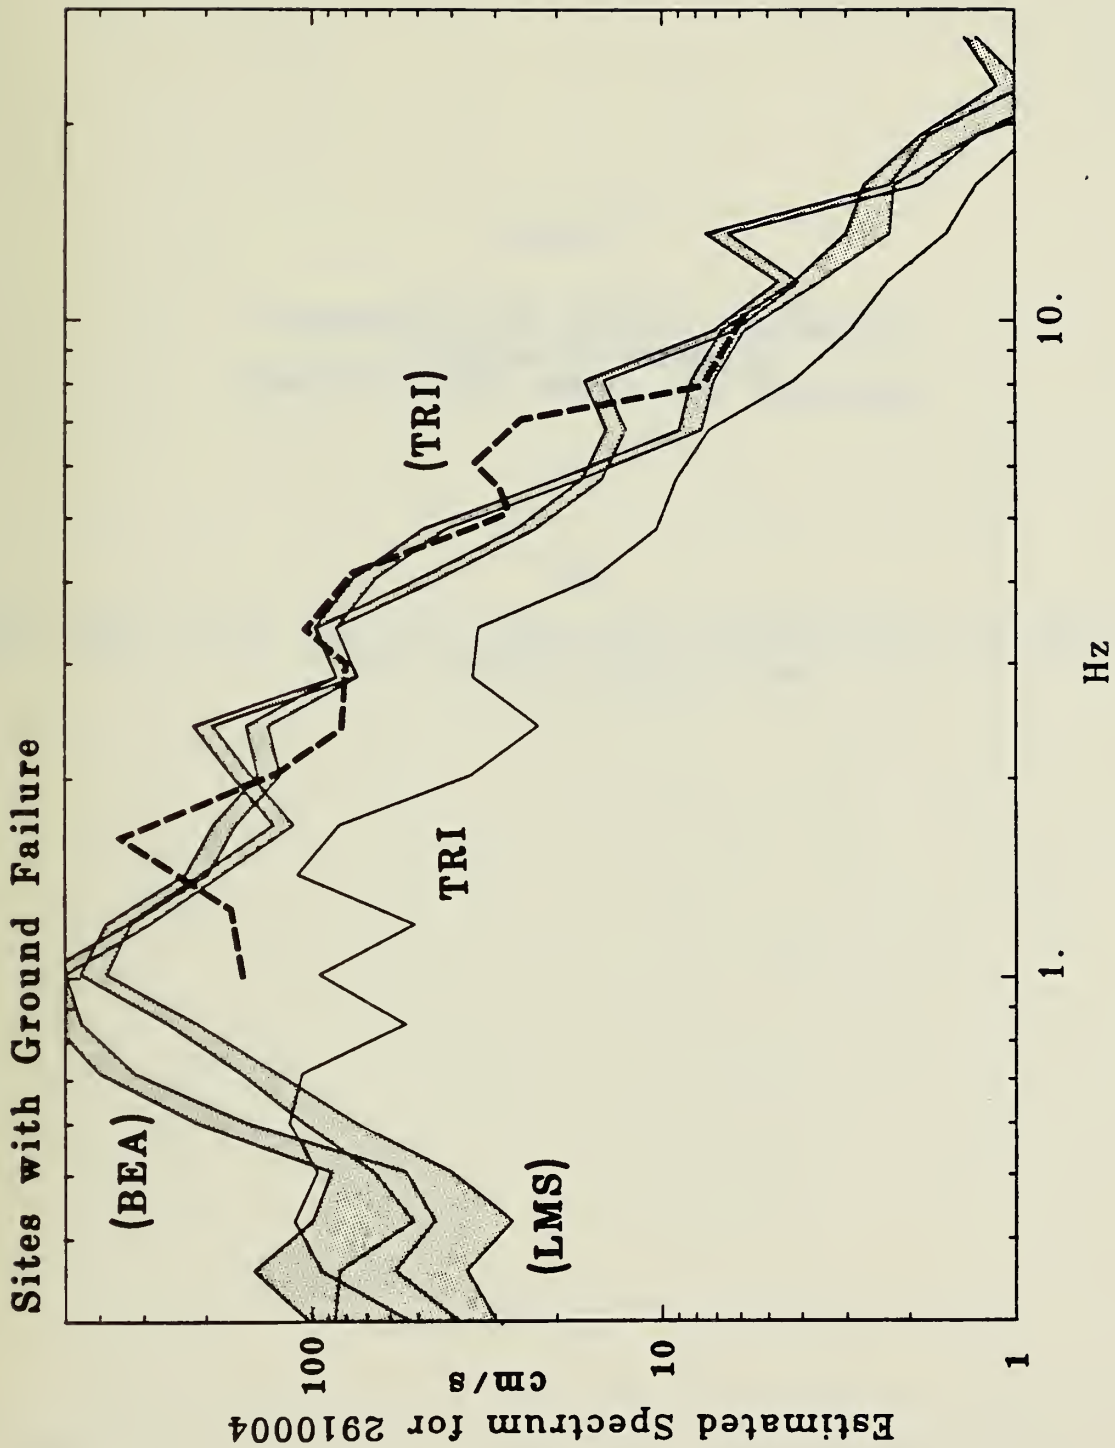
Figure 10 shows the extrapolated spectra for the main shock at two sites located on the 1912 hydraulic fill in the Marina, stations BEA and LMS. As in Figures 8 and 9, these extrapolations are plotted using 85% confidence intervals. The spectrum labelled TRI was obtained from the accelerogram recorded on Treasure Island which had a peak ground acceleration of 16% g. Hanks (oral communication, 1990) has suggested using this accelerogram as an analog for the ground motion in the Marina. The thick dashed line is an extrapolation for the main shock ground motions at Treasure Island, obtained from the relative amplification of the station TRI to the Yerba Buena Island site (station YBI) determined from recordings of seven aftershocks by Jarpe et al. (1990) and the spectrum of the main shock recorded at station YBI.

Figure 10. Comparison of the extrapolated acceleration spectra for two sites within the 1912 hydraulic fill with an extrapolated acceleration spectrum for station TRI (heavy dashed line), located on Treasure Island, as determined from the relative amplification of the NS component of motion for seven aftershocks, and the main shock recording at station YBI on Yerba Buena Island. The recorded acceleration spectrum for station TRI is about a factor of three less than the extrapolated spectra.

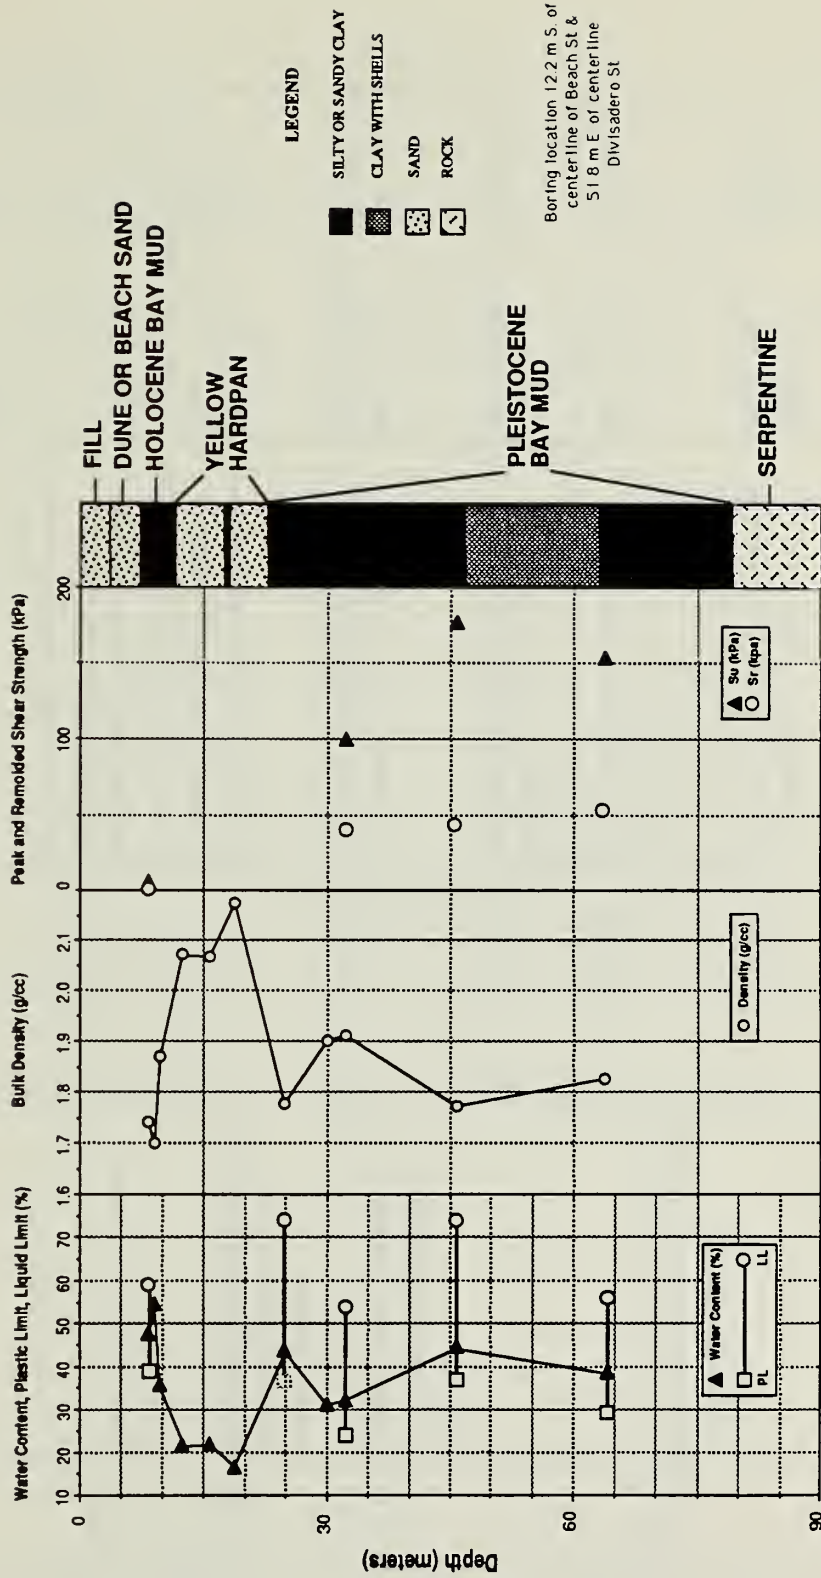
The soil column at the USGS boring site consists of 4.3 meters of filled sand overlying another 3.5 meters of (natural?) sand deposits. Below is an interbedded sequence of clayey-sand and clay to a depth of 11.6 meters interpreted to be the base of Holocene Bay Mud. The "Yellow hardpan", noted in the 1912 boring logs, is actually a layer of dense sand lying between 11.6 and 22.9 meters and is characterized by a distinct yellow-brown color and high penetration resistance. The lower 57.9 meters of the soil column consists of stiff dark greenish gray to olive-gray Pleistocene Bay Mud which overlies sheared serpentine at 79.5 meters.

Figure 2. Stratigraphy, and physical- and engineering-properties of the soil column at Winfield Scott School.

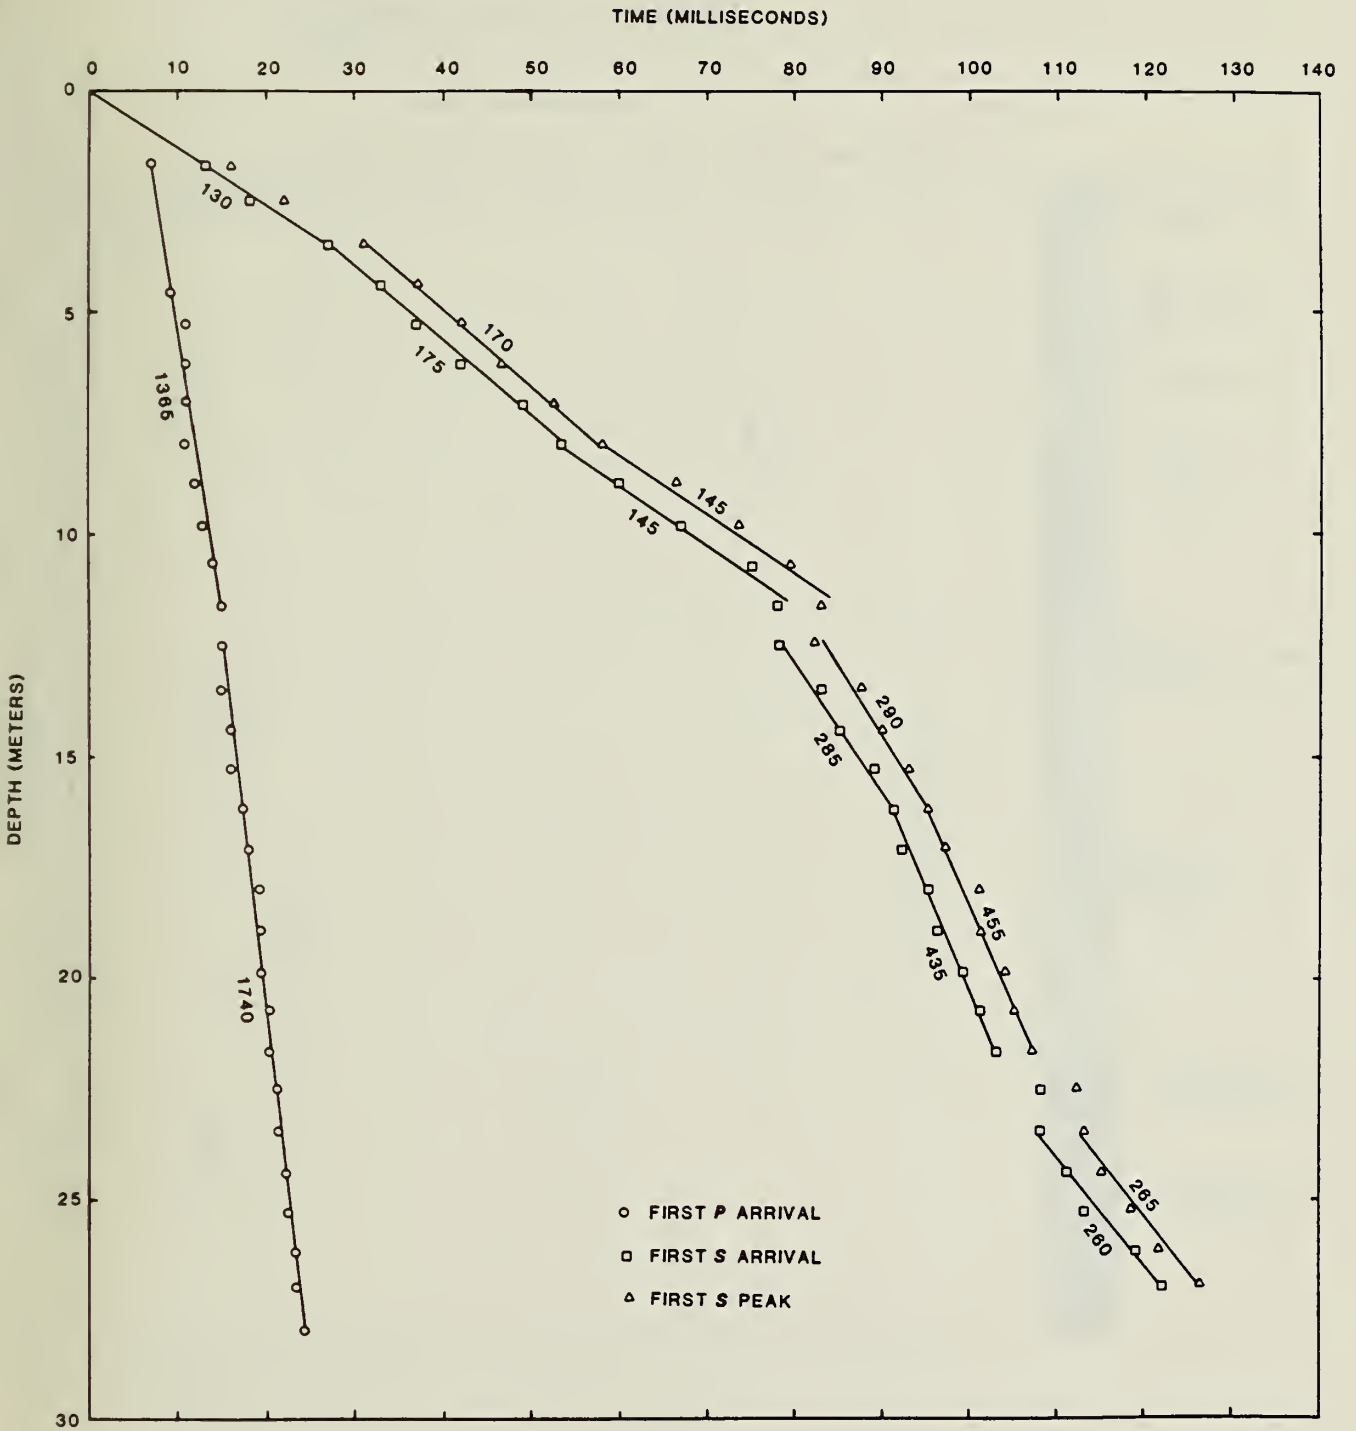
Figure 5. Seismic shear wave and compression wave travel times versus depth.

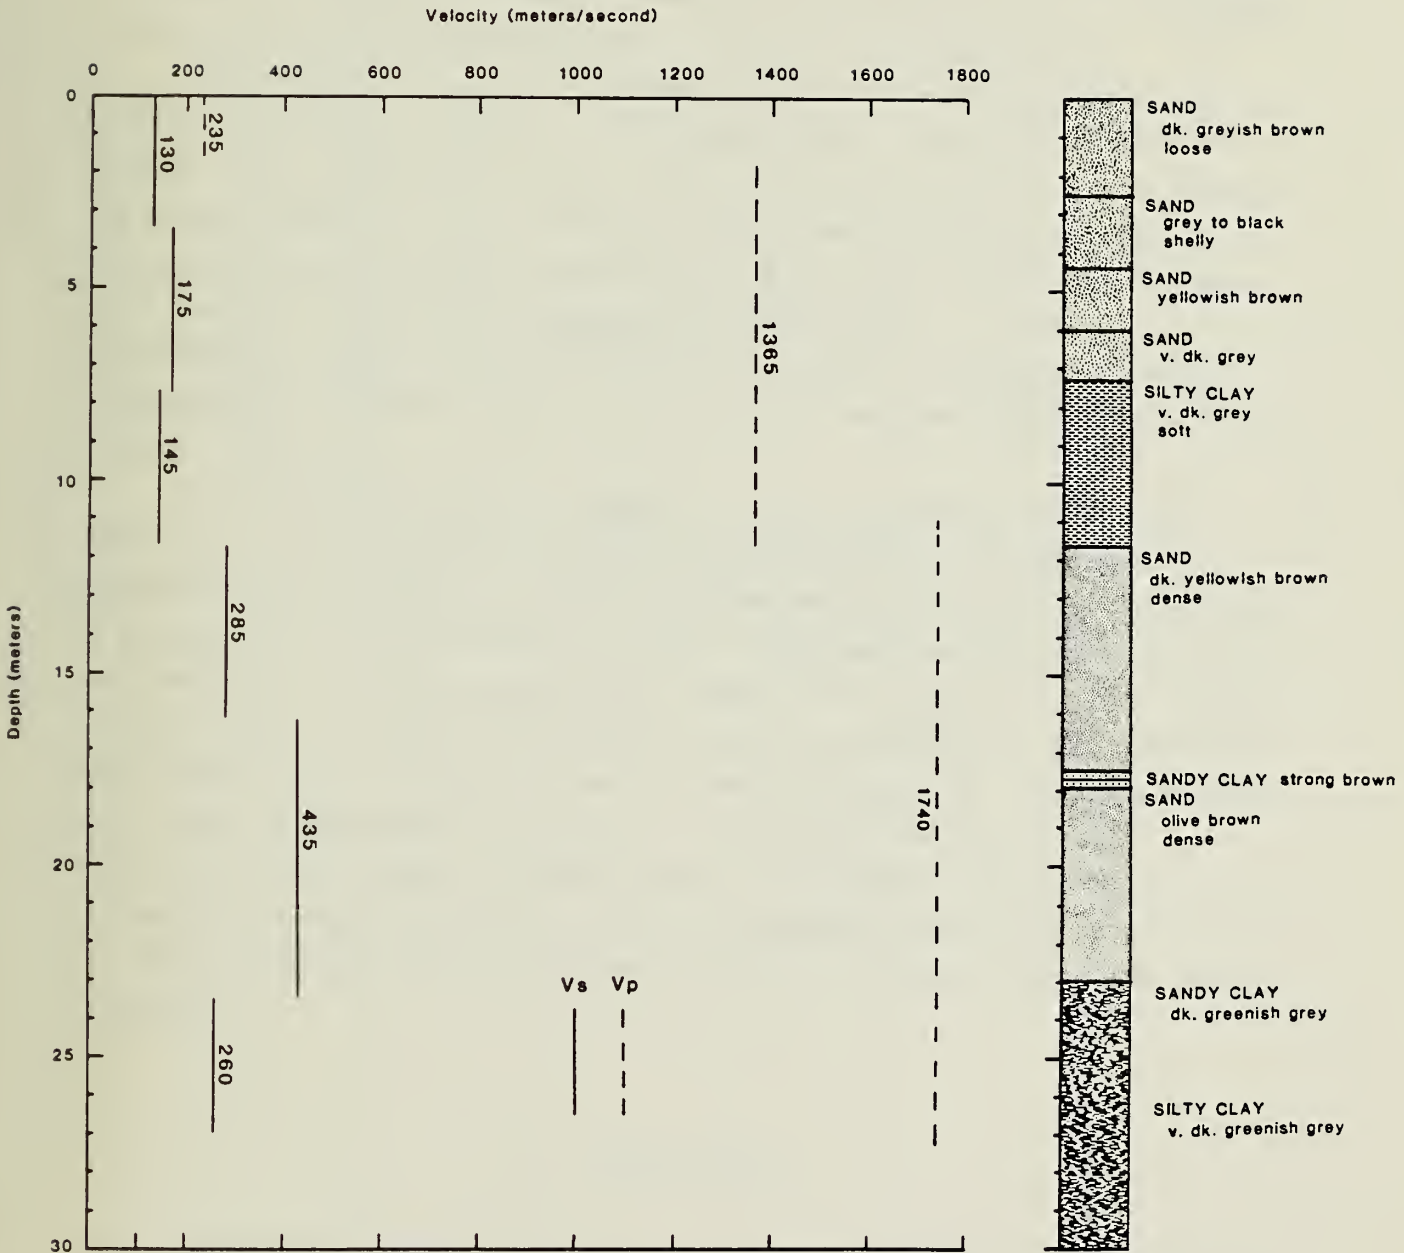
Data were taken starting at a depth of 1.66 m and then at 0.91 m intervals to a maximum depth of 28.18 m. An ES&G ES-1200 digital seismograph, triggered by an impact switch, was used to record the waveforms at a sampling rate of 1024 samples/channel/s. Travel times were determined for the first arrival and the first downward velocity maximum of the compressional waveforms; travel times were determined for the first S-wave arrival and the following two extrema in the recorded horizontal-component motions. The results are shown in Figure 5. The velocities, inferred from the travel time data, are shown in Figure 6.

Figure 6. Shear wave and compression wave velocity versus depth (meters/sec).
